HIGHWAY RESEARCH REPORT

INVESTIGATE USE OF LIME FOR TREATING CLAY SOIL FOR USE AS A BASE UNDER ASPHALT CONCRETE SURFACING

NO. M & R 633190

June 1967

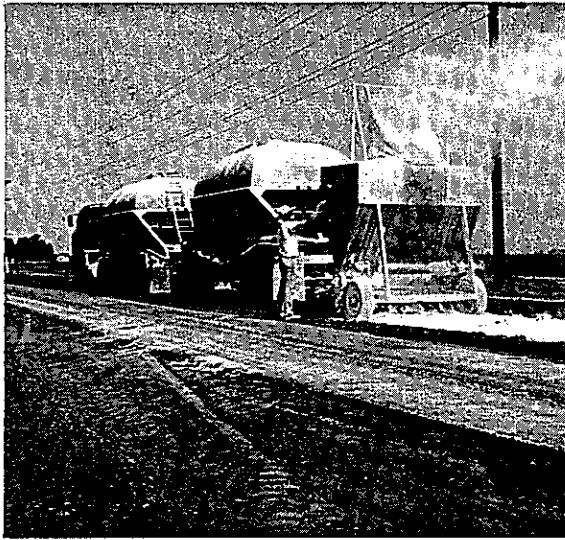
1) Rippers on motor grader initially scarified clay soil and then above photo shows lime being spread.

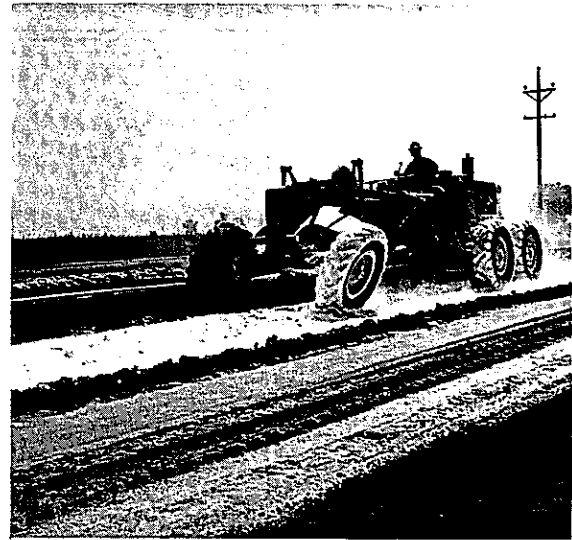
2) Motor grader covering lime and forming windrow for Woods Mixer.

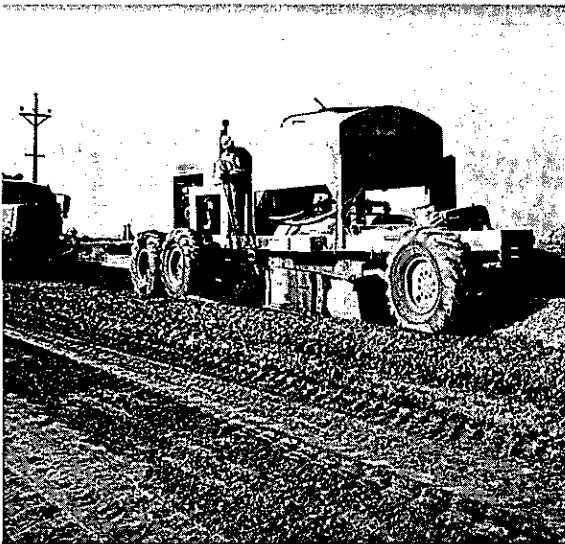
3) Woods Mixer mixing lime treated material.

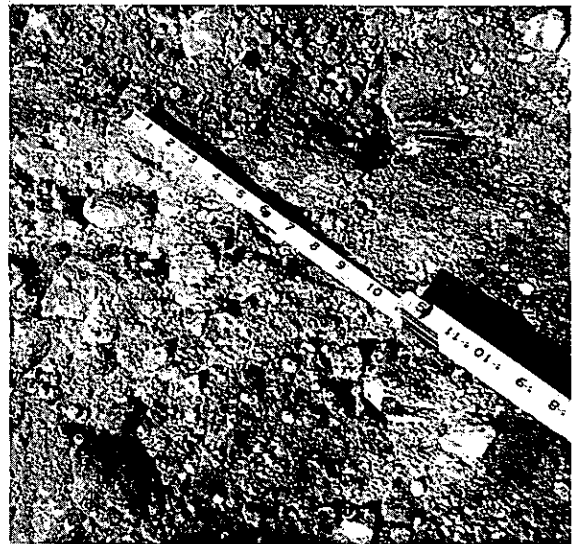
4) Close-up showing lime treated material in windrow after one pass of Woods Mixer.

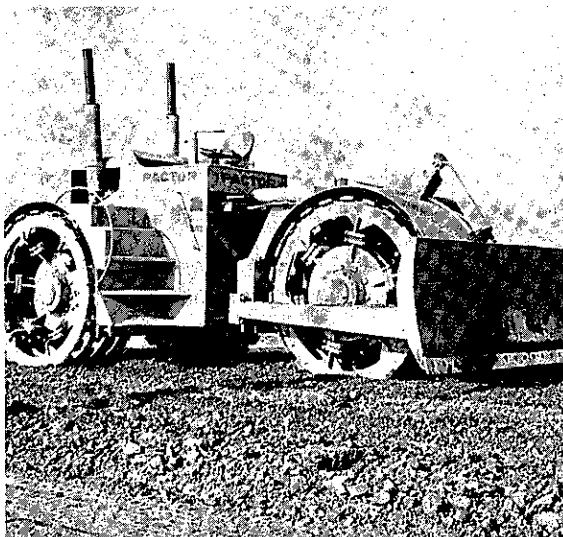
(5) Segmented 20,000 pound roller compacting lime treated material

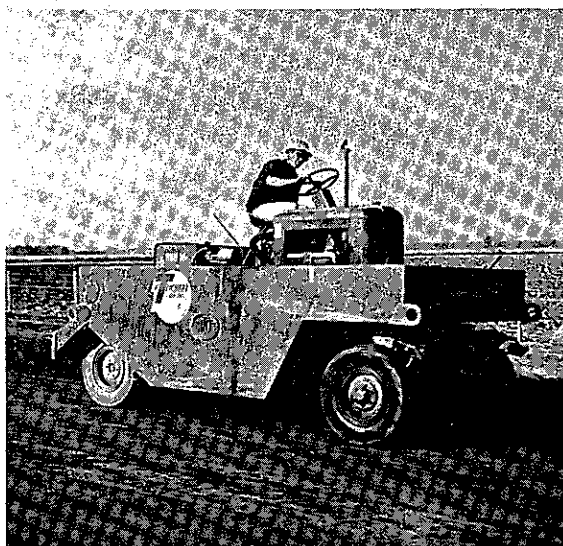
(6) Finish rolling with rubber tired compactor

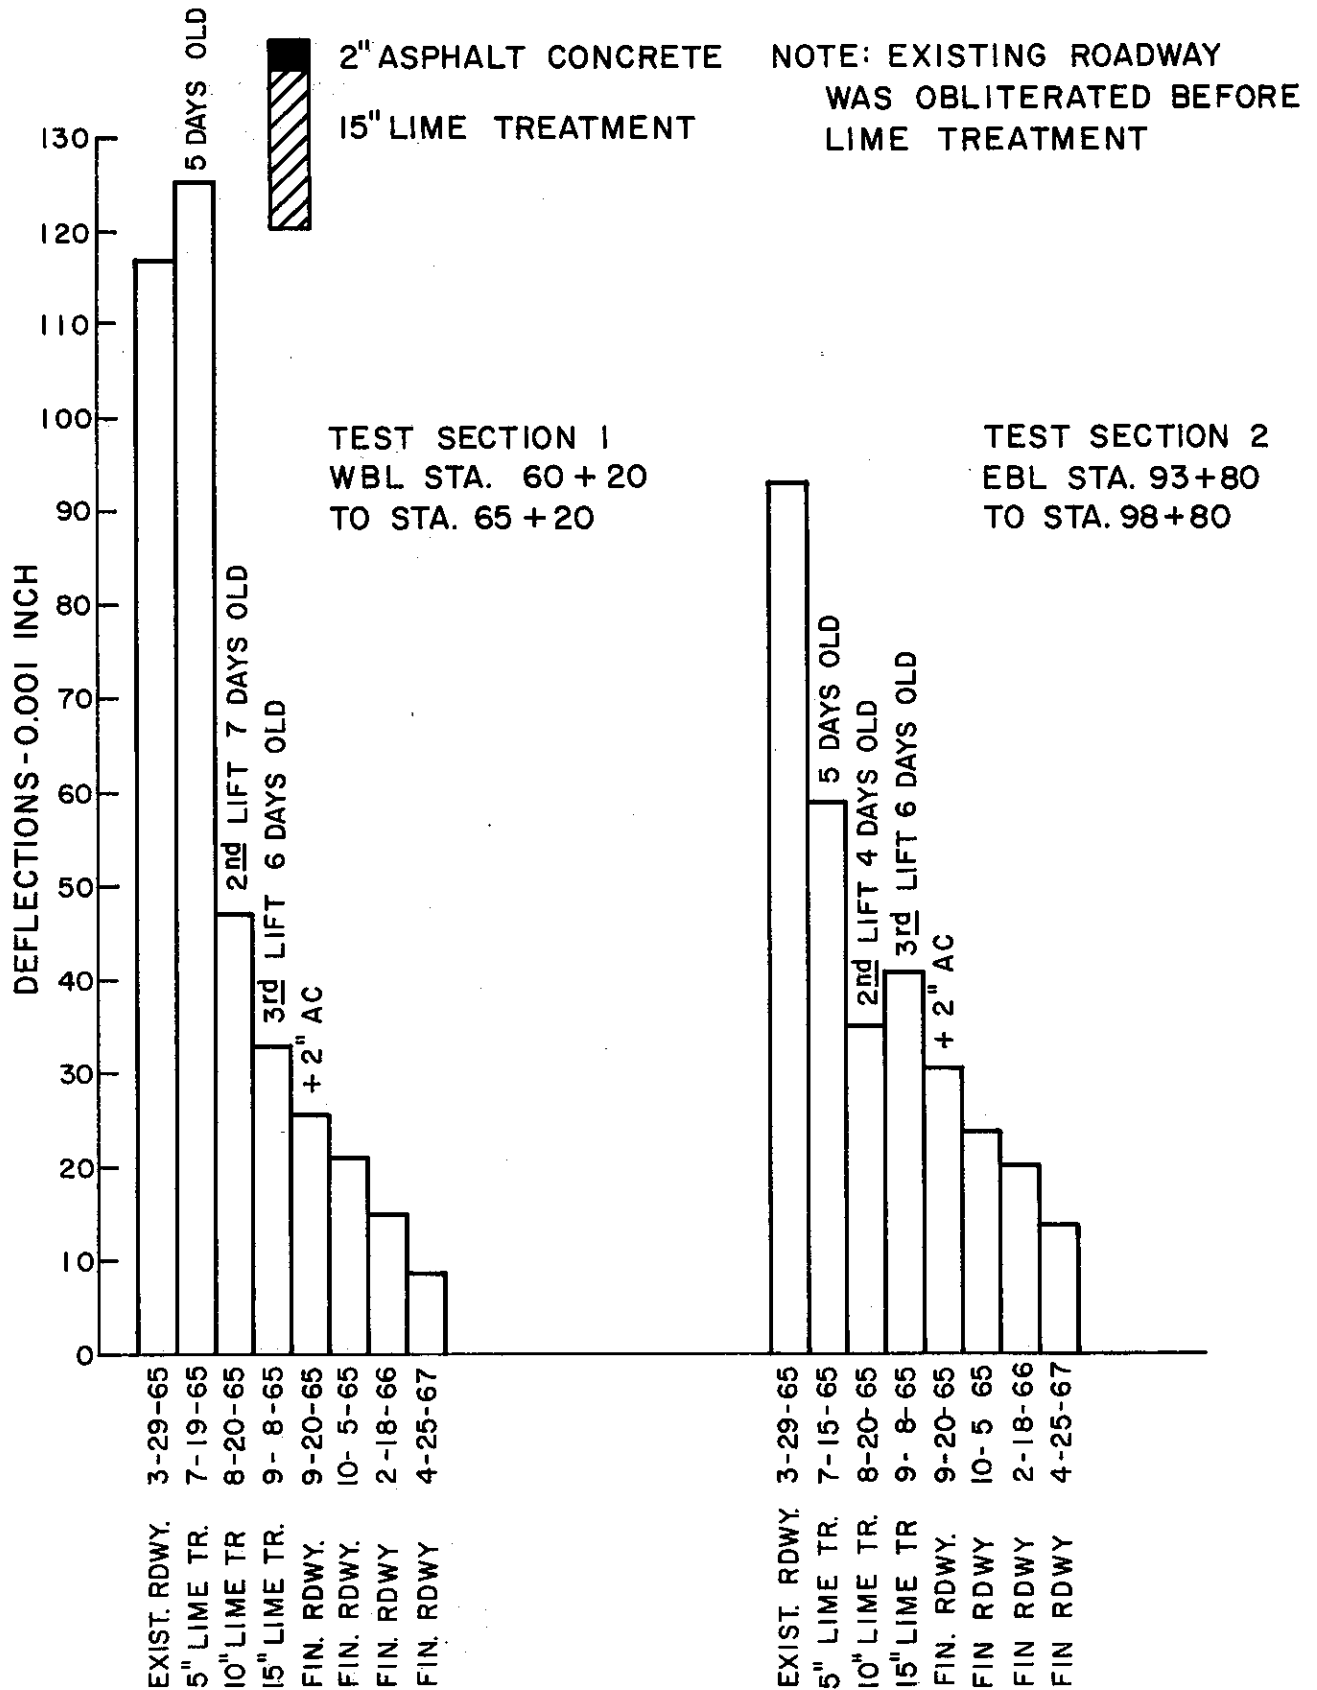
Figure 5

Average deflection measurements on the inner and outer wheel tracks are shown for the LTB test sections 1, 2, 3, and 4 (Figures 5, 5A, 6, and 6A). Deflection measurements were made on the existing roadway to give an indication of the level of deflection before construction. The average deflections of the test sections before lime treatment ranged from 0.018" to 0.117". The existing roadway was obliterated before construction of the new structural section.

After placing and compacting the first 5-inch layer of lime treated material, average deflections of the test sections ranged from 0.015" to 0.125". After the second layer was placed, the average deflections ranged from 0.015" to 0.047". Upon completion of the third layer, the average deflections ranged from 0.016" to 0.041".

Deflections on the finished roadway shortly after construction averaged 0.015" to 0.031". The tolerable deflection for this type of road is estimated to be around 0.032"2.

The deflections taken about 4 months after completion of construction were slightly lower (average ranged from 0.013" to 0.026"). About 10 inches of rain had fallen during this period.

About 1½ years after completion of construction, the average deflections ranged from 0.009" to 0.015".

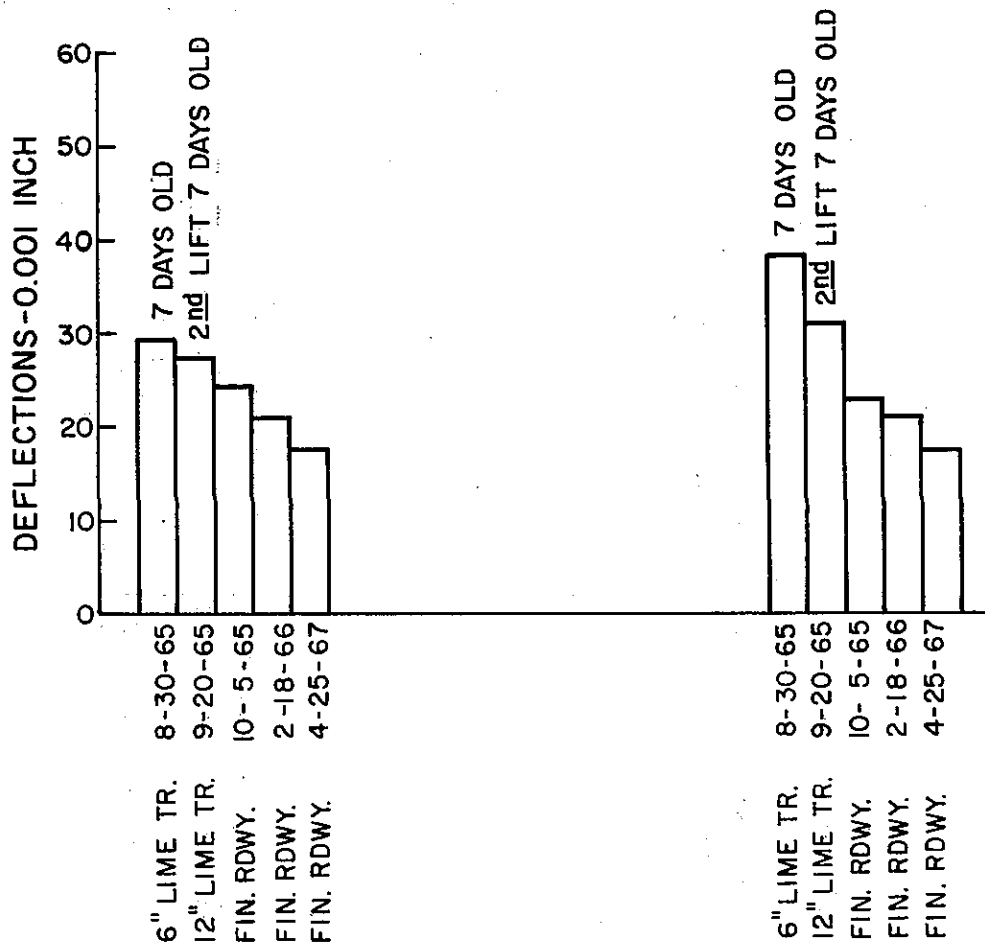
Figure 7A

This section of road was constructed on new alignment. Average deflection measurements on the inner and outer wheel tracks are shown for the LTS-AB sections 5 and 6, on Figures 7 and 7A. Average deflections ranged from 0.029" to 0.049" on the first 6 inches of lime treated soil after 7 days of compacted curing time. Average deflections ranged from 0.026" to 0.031" after the second 6-inch layer of lime treatment and 0.022" to 0.025" after the 6-inch layer of untreated aggregate base and 2 inches of asphalt concrete surfacing were placed.

Average deflections about 4 months after construction ranged from 0.021" to 0.027". About 10 inches of rain had fallen during this period. The tolerable deflection for this type of road is estimated to be around 0.032"². Average deflections 1½ years after completion of construction ranged from 0.017" to 0.019".

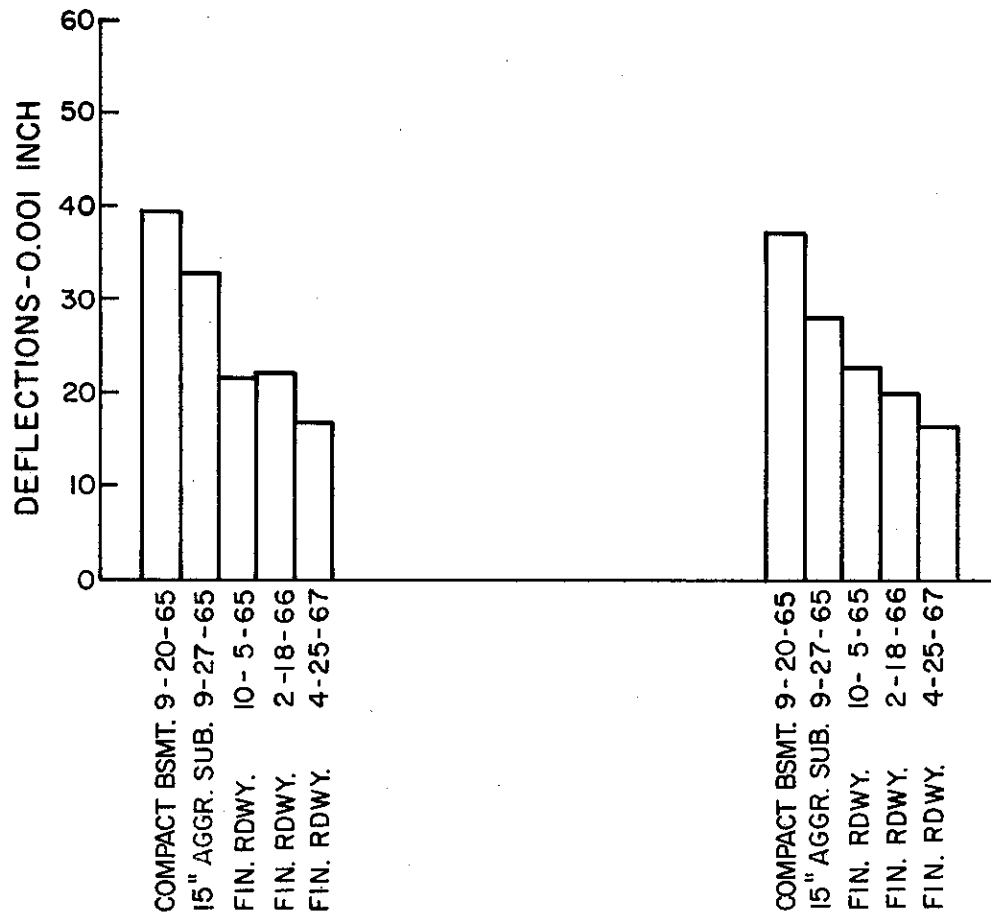
Figure 8

Average deflections on the basement soil ranged from 0.037" to 0.039". After 15 inches of aggregate subbase was placed, the average deflections ranged from 0.028" to 0.033" and 0.021" to 0.023" after 6 inches of aggregate base and 2 inches of asphalt concrete were placed. (Figure 8).

Average deflections ranged from 0.019" to 0.022" about 4 months after construction. There was about 10 inches of rainfall during this period. The tolerable deflection for this type of road is estimated to be around 0.032"². Average deflections 1½ years after completion of construction was 0.017".
